Ignition Coil Housing Cracked (58/12)

Concerns **Ignition coil**

Information: **Procedure for replacing faulty ignition coils.**

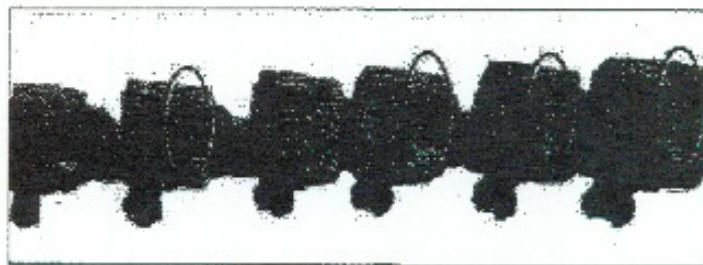
Figure 1

Cracks in the ignition coil housing (⇒ *Figure 1*) can cause corrosion, which can result in a rough-running engine and misfiring.

Action Required: If at least one ignition coil is diagnosed as faulty (see damage comparison ⇒ *Figure 1*), all ignition coils must be replaced.

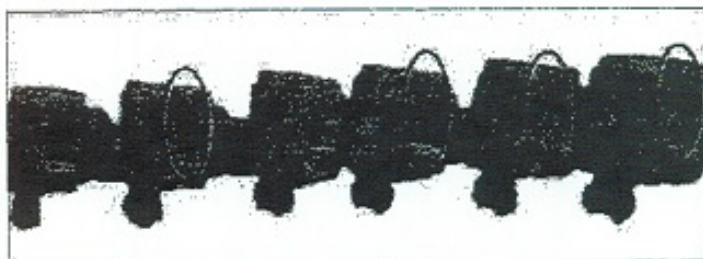
Figure 1

Cracks in the ignition coil housing (\Rightarrow Figure 1) can cause corrosion, which can result in a rough-running engine and misfiring.

Action Required: If at least one ignition coil is diagnosed as faulty (see damage comparison ⇒ *Figure 7*), all ignition coils must be replaced.

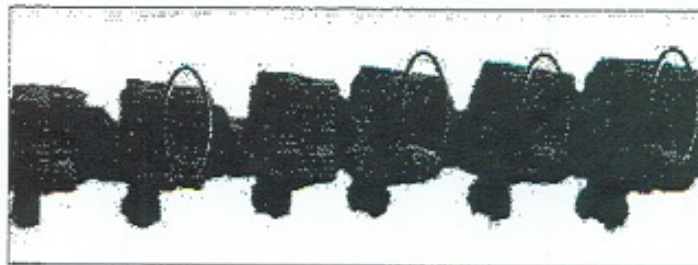
Figure 1

Cracks in the ignition coil housing (\Rightarrow Figure 1) can cause corrosion, which can result in a rough-running engine and misfiring.

Action Required: If at least one ignition coil is diagnosed as faulty (see damage comparison \Rightarrow Figure 1), all ignition coils must be replaced.

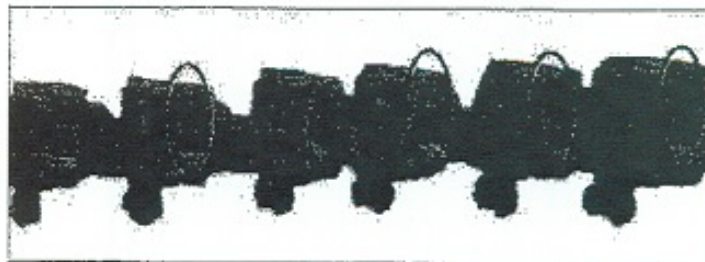
Figure 1

Cracks in the ignition coil housing (⇒ *Figure 1*) can cause corrosion, which can result in a rough-running engine and misfiring.

In the event of a complaint about a rough-running engine and misfiring, the ignition coils must be checked visually for signs of damage.

If at least one ignition coil is diagnosed as faulty (see damage comparison ⇒ *Figure 1*), **all ignition coils** must be replaced.

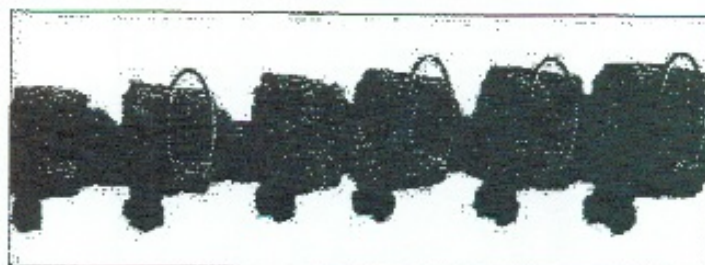
Figure 1

Cracks in the ignition coil housing (⇒ *Figure 1*) can cause corrosion, which can result in a rough-running engine and misfiring.

Action Required: In the event of a complaint about a rough-running engine and misfiring, the ignition coils must be checked visually for signs of damage.

If at least one ignition coil is diagnosed as faulty (see damage comparison ⇒ *Figure 1*), **all ignition coils must be replaced.**
