eRam Wing Actuation Kit*

996 Turbo Spoiler Relay Info

66 72 Assignment of spoiler drive, relays and instrument cluster

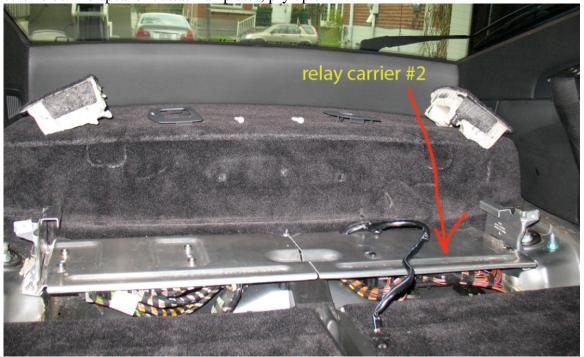
Remove the rear shelf (normally with Bose bass modules) behind back seats, remove

screws behind speaker eustachian plates, pry up shelf.

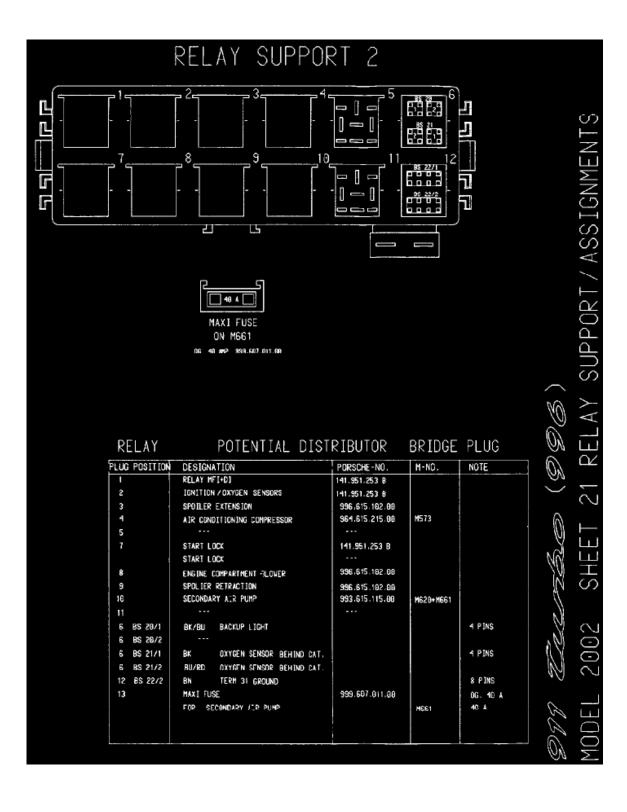
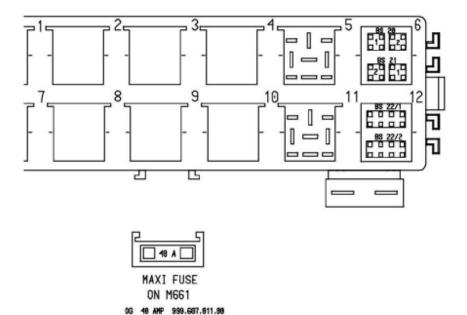
(998) 21 RELAY SUPPORT/ASSIGNMENTS 2004

RELAY SUPPORT 2

RELAY POTENTIAL DISTRIBUTOR BRIDGE PLUG

LUG POSITION	DESIGNATION	PORSCHE-NO.	M-NO.	NOTE
1	RELAY MFI+DI	141.951.253 B		
2	IGNITION OXYGEN SENSORS	141.951.253 B		
3	SPOILER EXTENSION	996.615.192.00		
1	AIR CONDITIONING COMPRESSOR	961.615.215.00	M573	
5				
7	START LOCK	141.951.253 B		
	START LOCK			
8	ENGINE COMPARTMENT BLOVER	996.615.192.09		
9	SPOLIER RETRACTION	996.615.102.00		
10	SECONDARY AIR PUMP	993.615.115.00	M628+M661	
11				
6 BS 20/1	BK/BU BACKUP LIGHT			4 PINS
6 BS 29/2				
6 BS 21/1	BK DXYGEN SENSOR BEHIND CAT.			4 PINS
6 BS 21/2	BU/RD OXYGEN SENSOR BEHIND CAT.			
12 BS 22/2	BN TERM 31 GROUND			8 PINS
13	MAXI FUSE	999.607.011.00		0G, 49 A
	FOR SECONDARY AIR PUMP		M661	40 A
