## Disabling PASM – 997 Turbo

### Disabling the PASM in a 997 Turbo

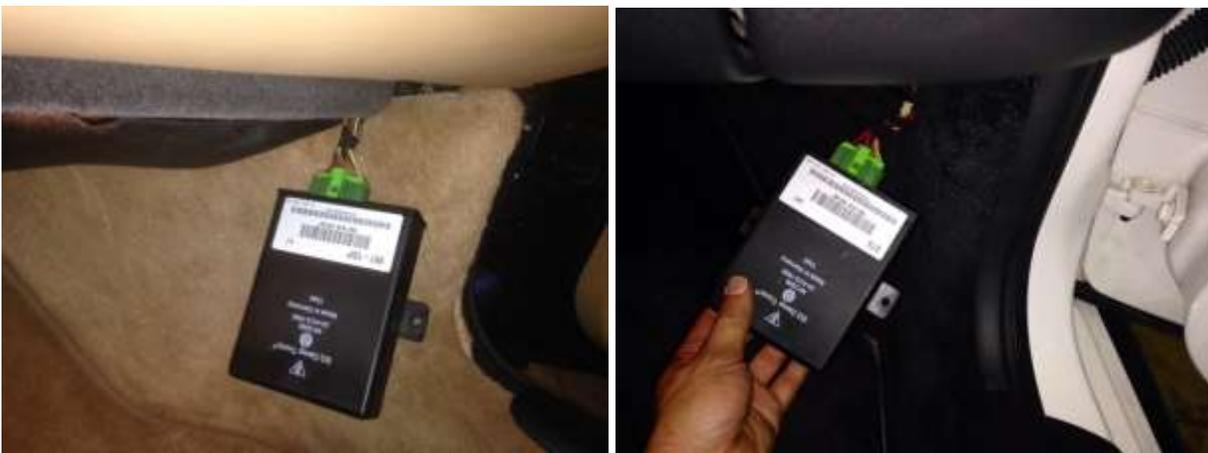
SG Damp Tronic Module removal from the frame: It clips into the frame. Pull the carpet back on the right side, behind the kick panel ahead of the door. Located near the top of the carpet. It clips into the frame and is found at the top of the carpet.

1. Unplug the PASM module in the passenger side footwell on the right side (not the center console connection).
2. Use the Durametric to change the Gateway entry for PASM to **'Not Installed'**. Sport mode works fine and no other errors are present.
